Monitoring Data Record

Project Title: I-2511CB (I-85 Widening) COE Action ID: 200221534  
Stream Name: Town Creek (Site 5) DWQ Number: 040271  
City, County and other Location Information: Rowan County, I-85 Widening (-TI-PINC Sta. 20+35)  
Date Construction Completed: Water turned on 12/6/06, Stream reforestation completed 12/13/06  
Monitoring Year: ( 5 ) of 5  
Ecoregion: \_\_\_\_\_ 8 digit HUC unit 03040103  
USGS Quad Name and Coordinates: \_\_\_\_\_

# Town Creek

Year 5 Winter – January 2012

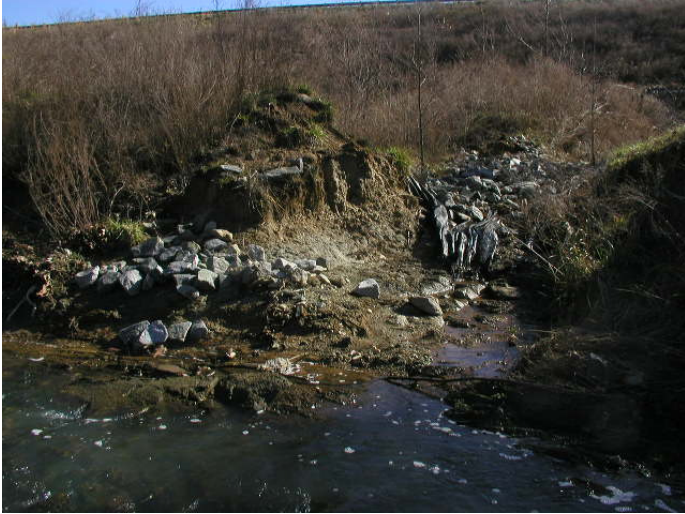
The Town Creek stream relocation is stable for the Year 5 Winter evaluation. NCDOT repaired the left bank at Sta. 16+50 on 8/3/11 by using the rock from the rock vane that was installed to construct the toe protection. The bank above the toe protection was graded at a 3:1 or flatter slope. Some minor bank erosion on the right bank @ Sta. 13+00 that was noted previously has seen little or no change since the last evaluation.

Date Inspected 1/25/12	-TI- PINC Sta. 13+00				
Structure Type					
Is water piping through or around structure?					
Head cut or down cut present?					
Bank or scour erosion present?	Bank erosion on right bank at drainage ditch				
Other problems noted?

Erosion on right bank @ -TI- PINC Sta. 13+00

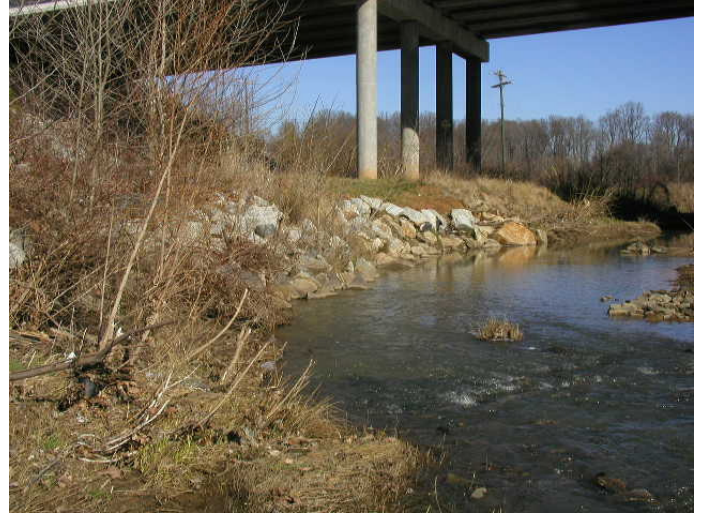
Repaired left bank @ -TI- PINC Sta. 16+50
